# CERTIHOME

AI-GENERATED HOME REPORT (GEN2)

## Possible Purchase

Wy 182001

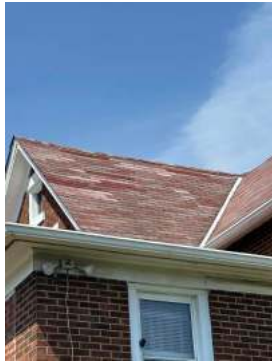
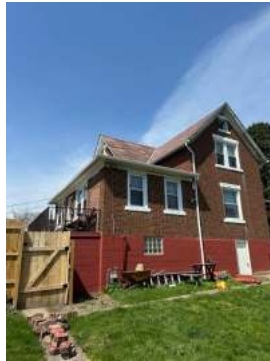
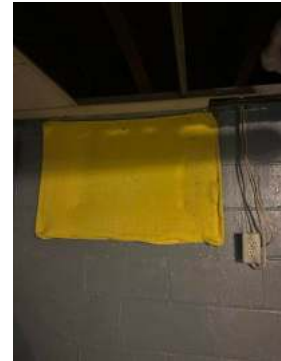
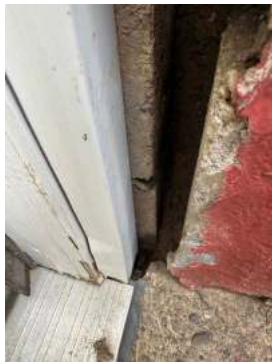
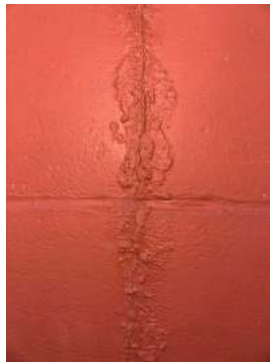
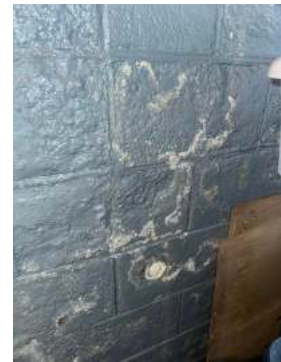
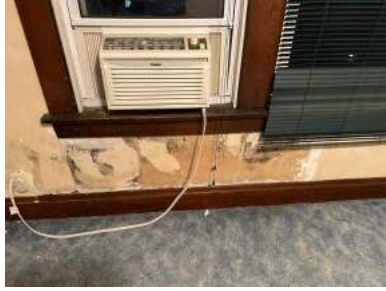
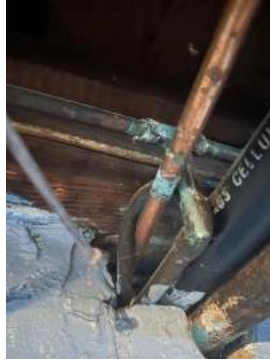
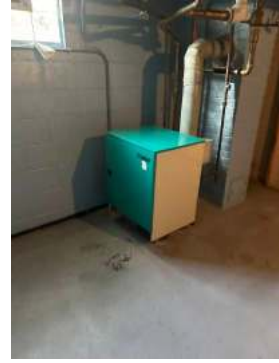
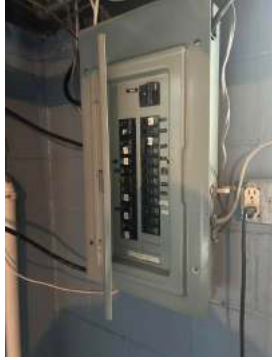
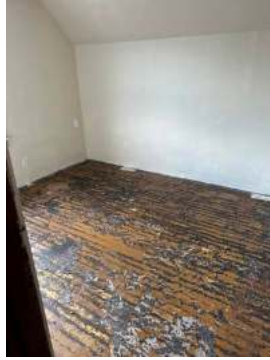
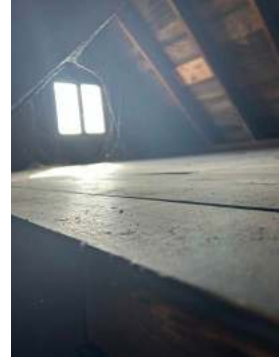
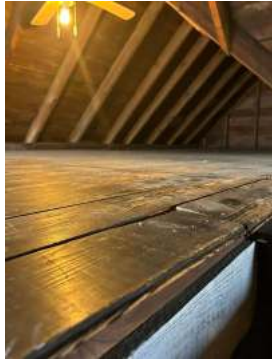
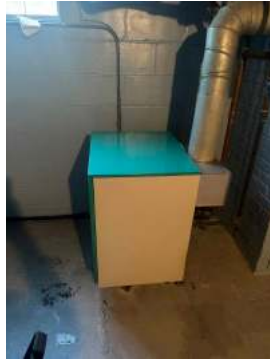
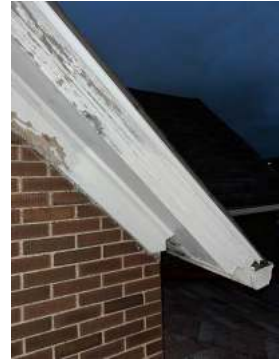
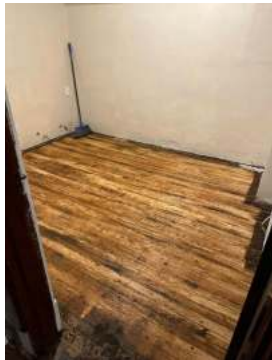
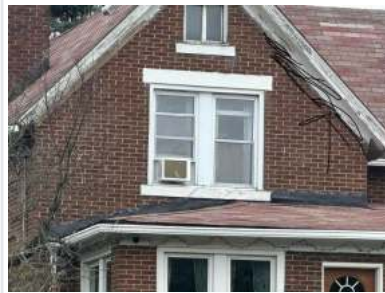
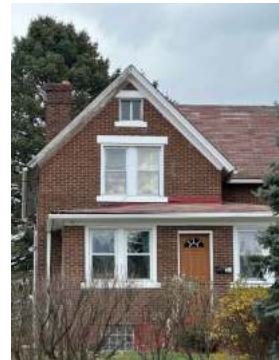
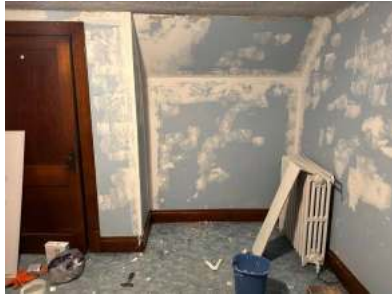
## D Detailed Findings

**Information:** Roof shingles appear uneven/patchy in multiple areas from ground views. Exterior gable/rake trim shows peeling paint and weathering, indicating deferred exterior maintenance that can allow moisture intrusion into wood components.

**Information:** A vertical crack is visible in painted masonry, and there appears to be deterioration/voiding at a joint/edge near an exterior opening. Cracks and gaps can allow water entry and accelerate masonry deterioration.

**Information:** White mineral deposits (efflorescence) and paint deterioration are visible on a basement masonry wall, suggesting moisture movement through the wall.

**Information:** A copper pipe joint shows heavy green corrosion consistent with a current or prior leak at/near the fitting.

**Information:** Moisture is visible on the basement floor near the mechanical area, which may indicate seepage, condensation, or plumbing/HVAC-related moisture.

- Basement masonry shows efflorescence and paint deterioration consistent with moisture migration
- Visible dampness on basement floor near mechanical area
- Corroded copper pipe joint suggests an active or past leak requiring prompt plumbing review
- Exterior trim has extensive peeling paint/weathering which can allow moisture intrusion and wood deterioration
- Interior wall deterioration/staining around window A/C area suggests moisture impact
